Verification Project Results

3.1 Trenching Installation Results

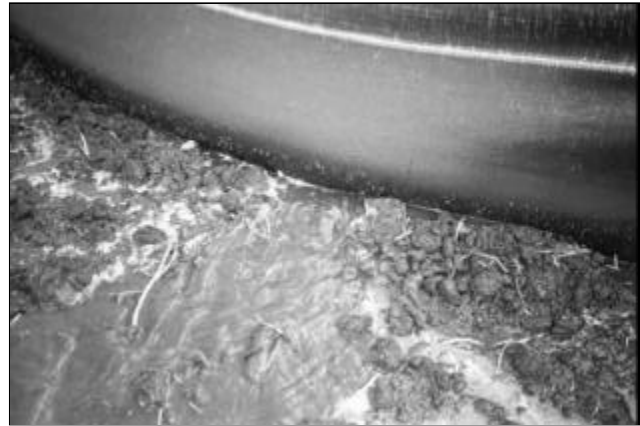
Close-up of a trench installation shows excessive piping of water under the silt fence.

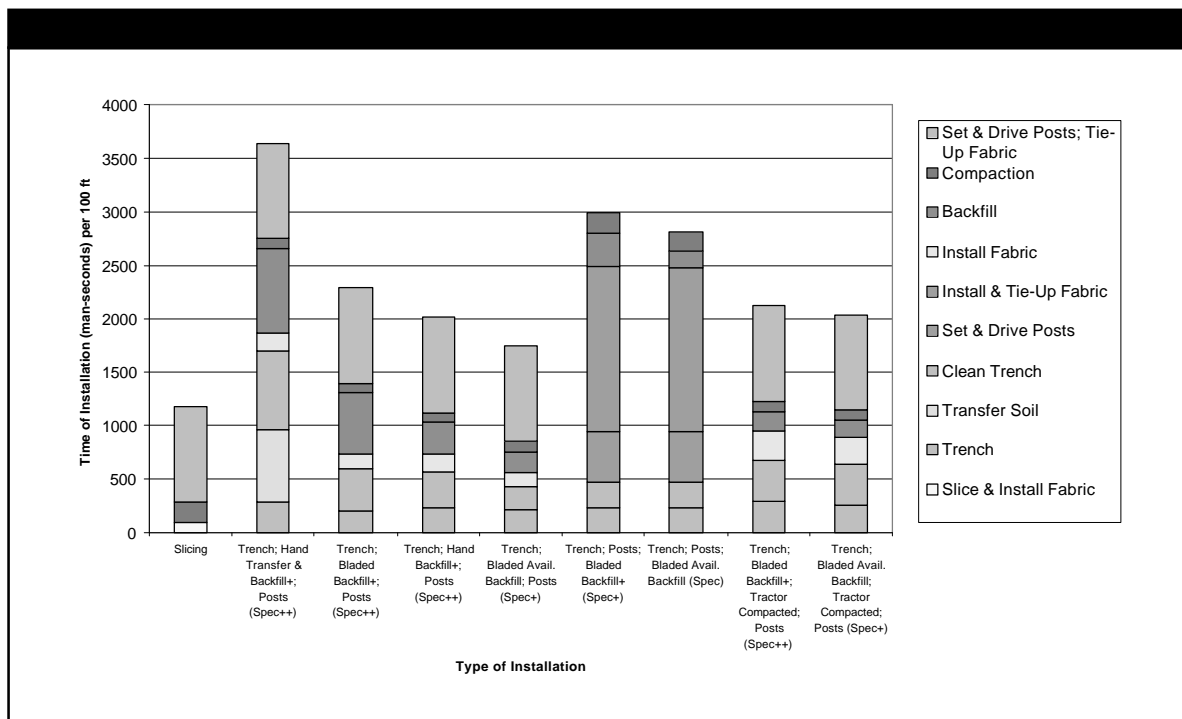
Figure 3. Silt fence productivity.

Figure 3 provides a comparison of the installation efficiency associated with various installation techniques. The trenching methods all required significant manual labor. Manual labor was required for hand-shoveling to both clean out and backfill the trench, for holding the fabric in place while trying to attach it to the posts, for holding the loose fabric in the trench while backfilling, and for the posting/tying effort.

Clearly any type of installation that included trenching required substantially greater installation time than the slicing technique. Among various trenching installations, those involving hand-cleaning of the trench, hand-transfer of the soil, and/or installation of posts prior to fabric installation and soil compaction took considerably longer to construct. If posts are installed before backfilling, fabric installation can be especially problematic – and time consuming – as the fabric must be held and stretched between posts while being tied to the posts, a task made more difficult by wind or too few laborers.

Figure 3 indicates that the time associated with digging a trench was comparable to the entire time required to slice the soil while simultaneously installing the fabric and subsequently compacting the soil with four passes. The time required to set and drive posts and tie-up fabric is basically the same for all installation techniques if fabric installation, backfilling (if required), and compaction are completed first, as long as the trencher can mechanically drive the posts. On average, slicing was more than twice as fast an installation technique than was trenching. As expected, installation efficiency improved with more mechanized installation practices.

Figures 3 and 4 show results for the majority of tests run. The soil in these tests was a clayey material that tended to break up into clods. These clods were very stable against piping and were resistant to progressive piping and erosion when backfilled in the trench. However, the voids between clods in the trench backfill provided channels for water to seep along the trench and, at points, beneath the silt fence.

Though not easily quantified, the benefits of compaction appear obvious from a review of Figures 3 through 7. Consistent trends in performance are reflected in all figures, showing that maximum compactive effort (static slicing and Spec+ + installations) significantly out-performs minimum compactive effort (Spec and Spec+).

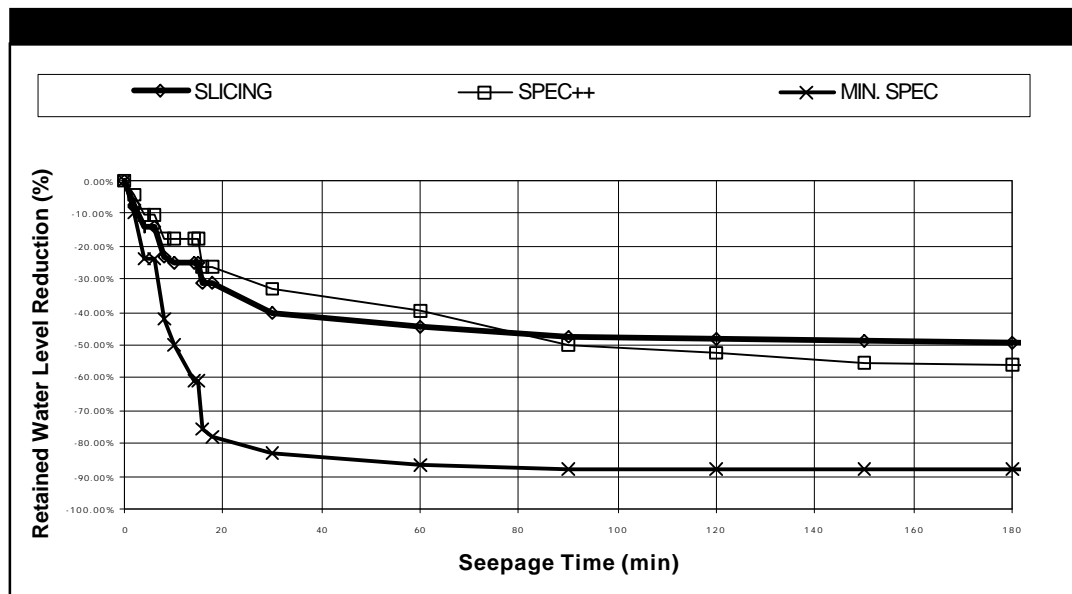
Figure 4: Average results of all runs: water level vs. time.

In general, improved performance was related to more rigorous installation efforts. More rigorous installation efforts include setting and driving posts and tying fabric to posts after compaction, over-backfilling the trench, mechanically compacting the filled trench, or any combination of these enhancements. The Spec installations consistently performed poorly, while the installations that included Spec+ installation techniques performed much better. Figures 4, 5, and 6 provide comparisons of the retention performance of the various classes of installation. Figure 4 presents the relative performance of all tests, including a variety of flow conditions, installation configurations, and soil types, while Figure 5 presents the relative performance of only those runs using standard conditions as outlined in Chapter 2.4. Figure 6 presents the relative performance of only those tests performed at Site #2 (new site or NS).

Figures 4, 5, and 6 show clearly that the Tommy static slicing method performed consistently as well as or better than the Spec++ trenching installation technique, better than the Spec+ installation technique for trenching, and much better than the Spec trenching techniques as defined in Chapter 2.2.

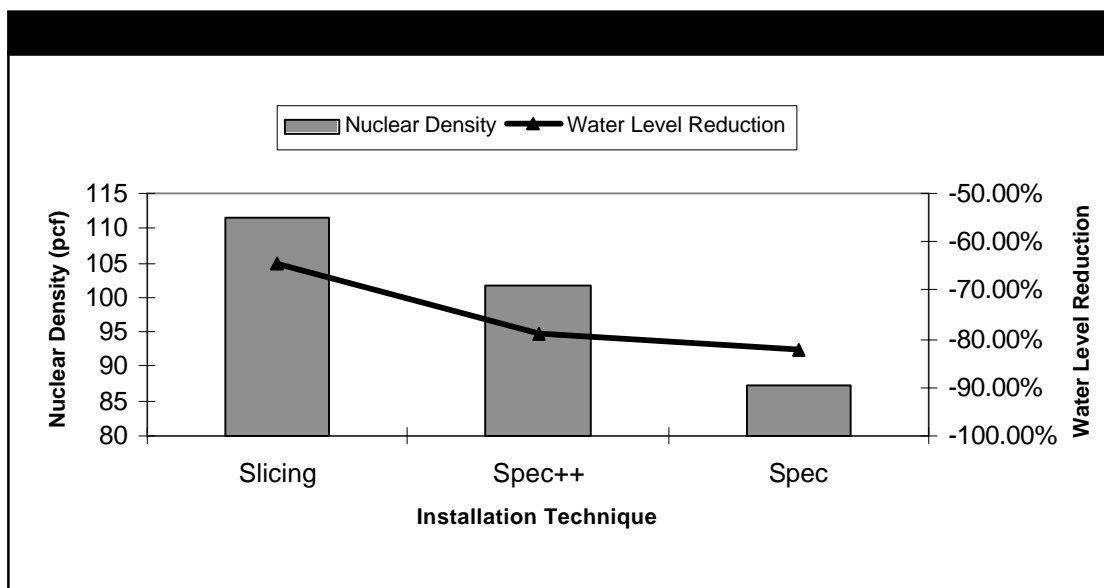
Figure 7. Backfill density vs. retained water level (average of “standard” tests).

Minimum (Spec) trenching-based specifications and Spec+ trenching-based specifications performed much more poorly than did the Spec++ trenching-based installations. This appeared to be directly related to the degree of compaction achieved in the trench as shown in Figure 7. Significantly lower compaction was achieved when posts were installed before compaction, when inadequate compaction effort was provided, and when there was insufficient backfill in the trench.

While the Spec++ trenching-based installations were able to retain 50 percent of the initial water level, less rigorous trenching-based installation techniques retained less than 20 percent as measured by the retained water level. In limited testing of the more erodible Site #2, the Spec++ trenching-based installation technique lost only 10 percent of its water level while the Spec installation experienced a 75 percent water level reduction.

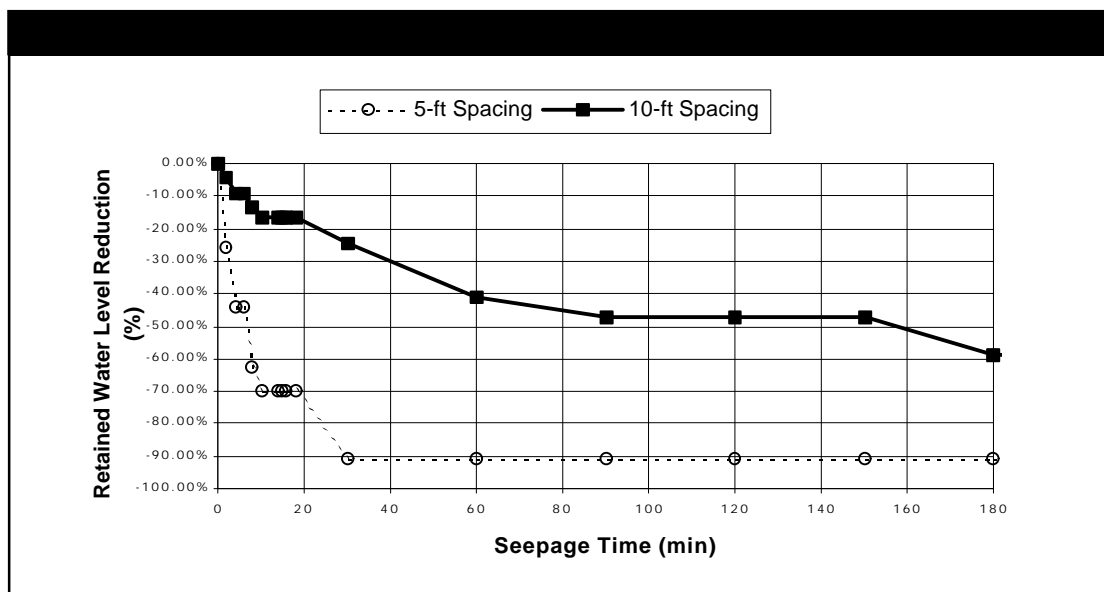
Figure 8. Effects of post spacing: water level vs. time.

Several tests were conducted using various post spacing. As shown in Figure 8, post spacing affected the permeability of the silt fence. Closer post spacing resulted in higher permeability while, conversely, greater spacing between posts reduced flow through the fabric. Visual examination of silt fence with varying post spacing appeared to indicate that at close spacing, the hydraulic pressure on the fence produced less stretching of the fence between posts. This tended to keep openings in the fabric from closing off. The opposite effect appeared with greater post spacing, resulting in fence heights at midpoint between the posts that were clearly much lower than at the posts. This appeared to stretch the fence horizontally and reduce the size of the fence openings.

The tests reported in Figure 8 reflect tests using runoff with a rather modest sediment load. As a result, initial tests resulted in excessive seepage using the 5-foot post spacing. To encourage retention, blinding of the fabric was enhanced by increasing post spacing to the maximum distance permitted in ASTM D 6462. It should be noted that there was also a trade-off between post spacing and the volume of runoff that could be retained.

Closer spacing of posts prevented sagging of the fence at the mid-point between posts, enabling the silt fence to pond, or retain greater volumes of water. Closer spacing of posts may be more appropriate, especially when retaining highly sediment-laden runoff; the sediments in the water will quickly block off the fabric openings, and the runoff will quickly impound behind the fence. Closer spacing of posts will both minimize fence sagging - increasing capacity - and maximize fence support - which will be needed to resist the increased pressure of the retained water. When the effects of post spacing became clear, a 6.5-foot spacing was selected as the standard for all additional testing in accordance with maximum spacing allowed in ASTM D 6462.

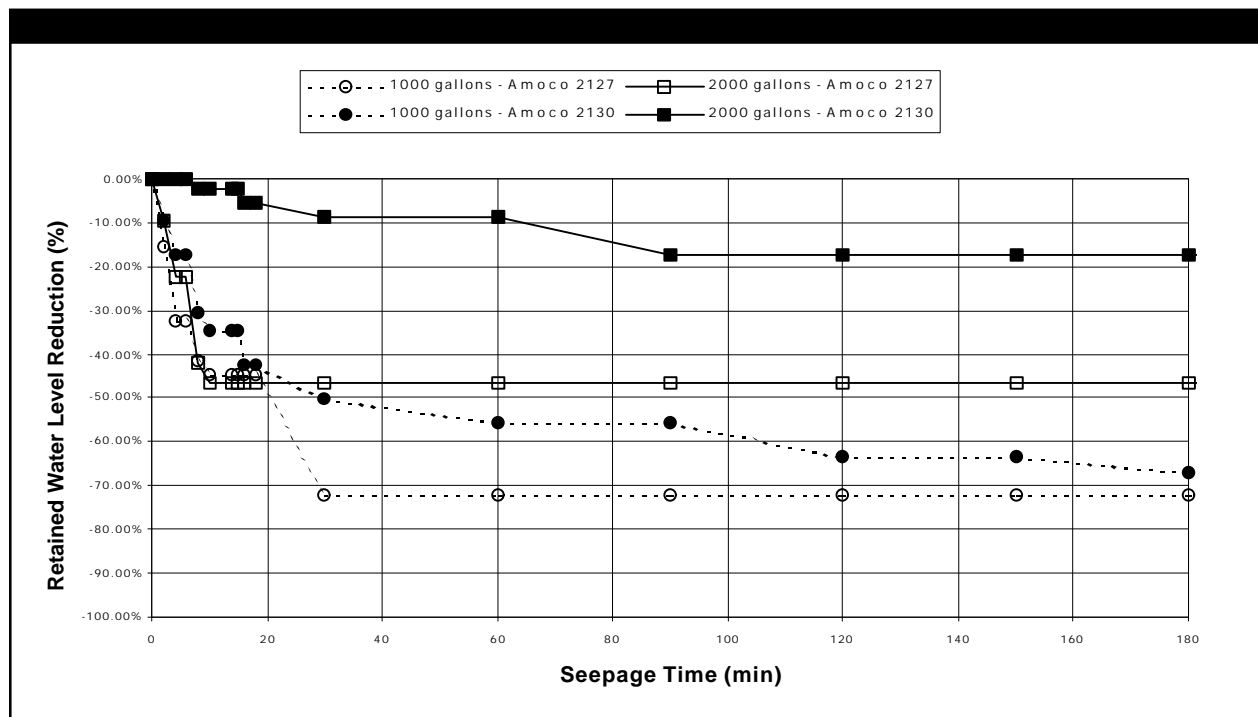
Figure 9. Effects of water applied - static slicing: water level vs. time.

One question that remained unanswered throughout the planning process concerned the amount of water required to create the desired level of retained runoff. Based on the sponsor's experience with similar tests, an initial application rate of 1,000 gallons was chosen. The water was applied over a 10-minute period, and the seepage was measured beginning at the end of the water application. Two trucks, each with a 1,000-gallon water tank, were available as sources of water. Standard tests were run using 1,000 gallons of water. During the testing program, greater amounts of runoff were applied in some tests to examine the effects of the amount of runoff. The results are shown in Figures 9 and 10.

Slicing and Spec+ + installations held up well under the higher head pressure created by the greater water volume, without the water undermining the installation. The greater hydraulic load stretched and tightened the fabric without causing undermining. Spec and Spec+ installations failed to hold the higher pressure and experienced increased seepage under the fabric. As mentioned earlier, Spec and Spec+ cannot be compacted as well as slicing and Spec+ + installations because the posts are typically installed first, interfering with mechanical compaction.

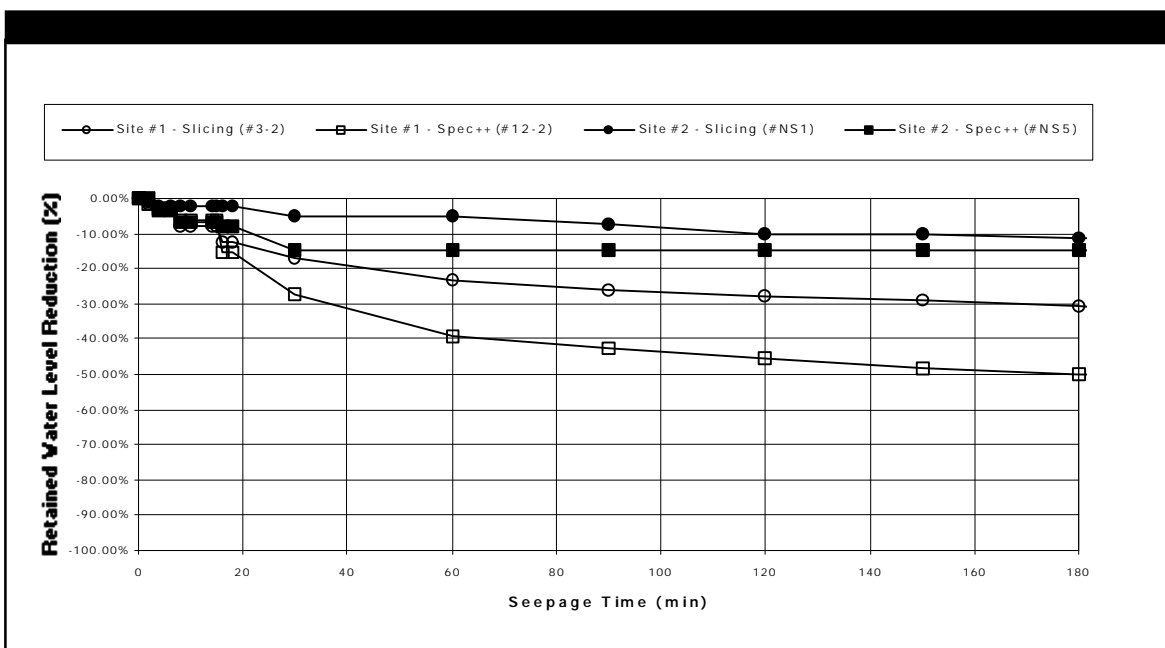
Figure 11. Effects of soil type: water level vs. time.

Figure 11 illustrates the difference soil type can make in fence performance. The figure shows testing results from both Site #1, a site composed of silty clay soils, and from Site #2, which was characterized by clay loam soils. The clay loam soil was more erodible, producing more sediment, and thus more quickly blinded the silt fence fabric. Additionally, the silt loam soils were more easily compacted. However, the modestly compacted silt loam backfill was prone to piping beneath the silt fence. The figure shows the importance of compaction. When high levels of compaction are achieved—as is characteristic with the slicing and Spec+ + trenching-based installation techniques—high levels of performance can be expected. Where only modest compaction is achieved—as is typical in Spec trenching-based installations—much poorer performance can be expected.

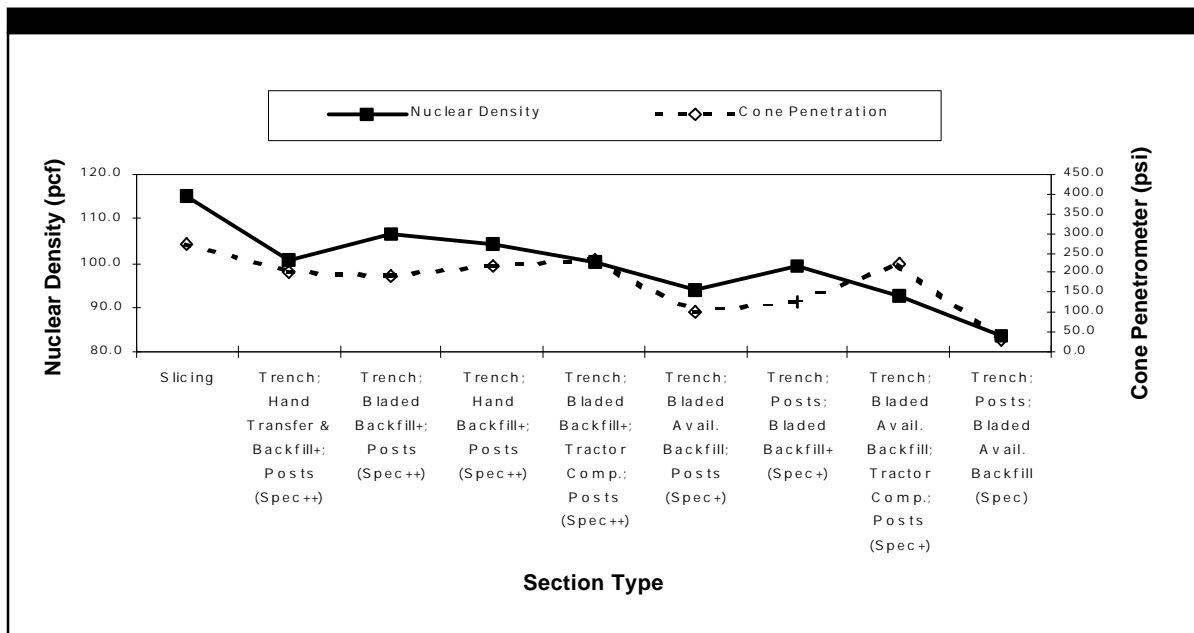
Figure 12. Nuclear guage vs. cone penetrometer.

Figures 12 through 14 compare data collected using the nuclear density gauge, a cone penetrometer, and a pullout apparatus (vendor created field device). Data for all three measuring techniques were collected from the same locations. The nuclear density gauge was assumed to provide the most accurate representation of the in situ soil conditions, as it is routinely calibrated and its use is standardized. Figure 15 shows a significant correlation between the cone penetrometer readings and the nuclear density measurements. This may indicate that the much easier, and less expensive, hand penetrometer can be used effectively as a field quality assurance tool.
